BUILDING & STANDARDS  
COMMISSION  
PACKET

**July 18, 2024**

## BUILDING & STANDARDS COMMISSION AGENDA

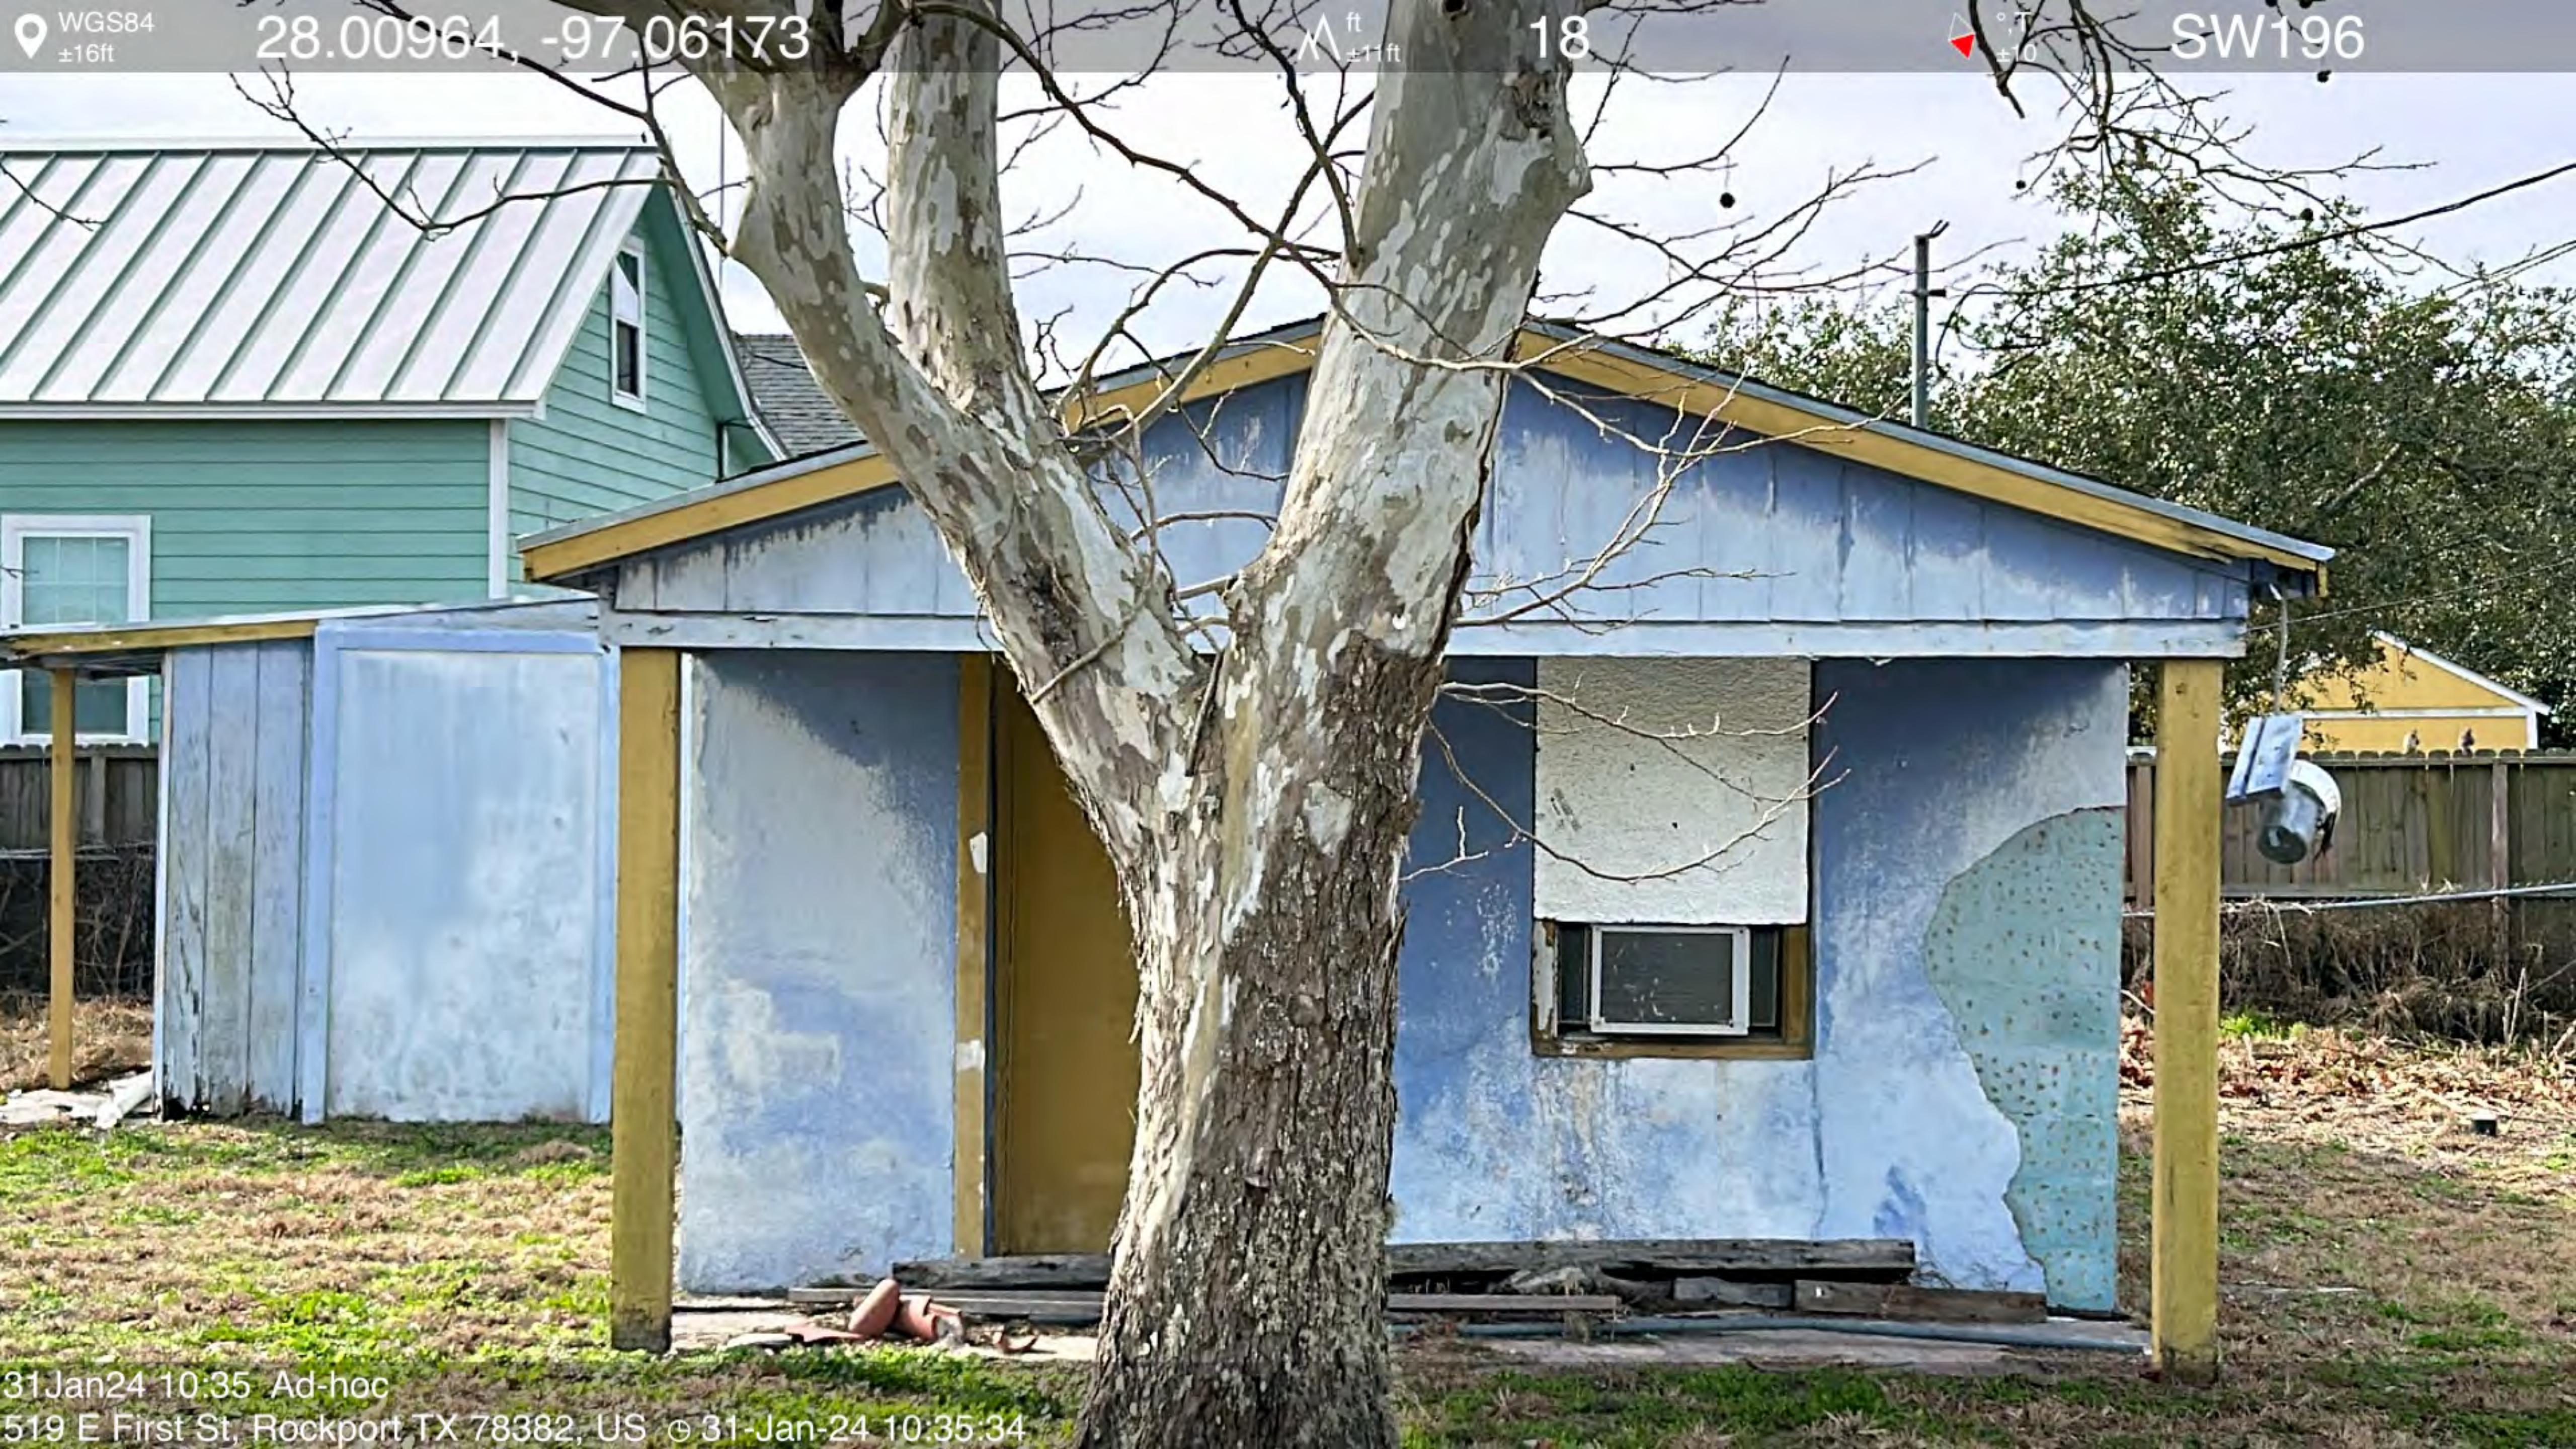
519 E First St, Rockport TX 78382, US © 31-Jan-24 10:35:34

A few of the defects of this structure; stucco is coming off of the cinder block structure, cracks throughout the structure, roof needs a complete repair, holes in the structure, roof is sagging, holes in the structure, porch is falling off, wood rot, the structure is sinking,

CE Officer Emerson is requesting that the structure be demolished, and the property be cleaned and cleared and returned to its natural state.

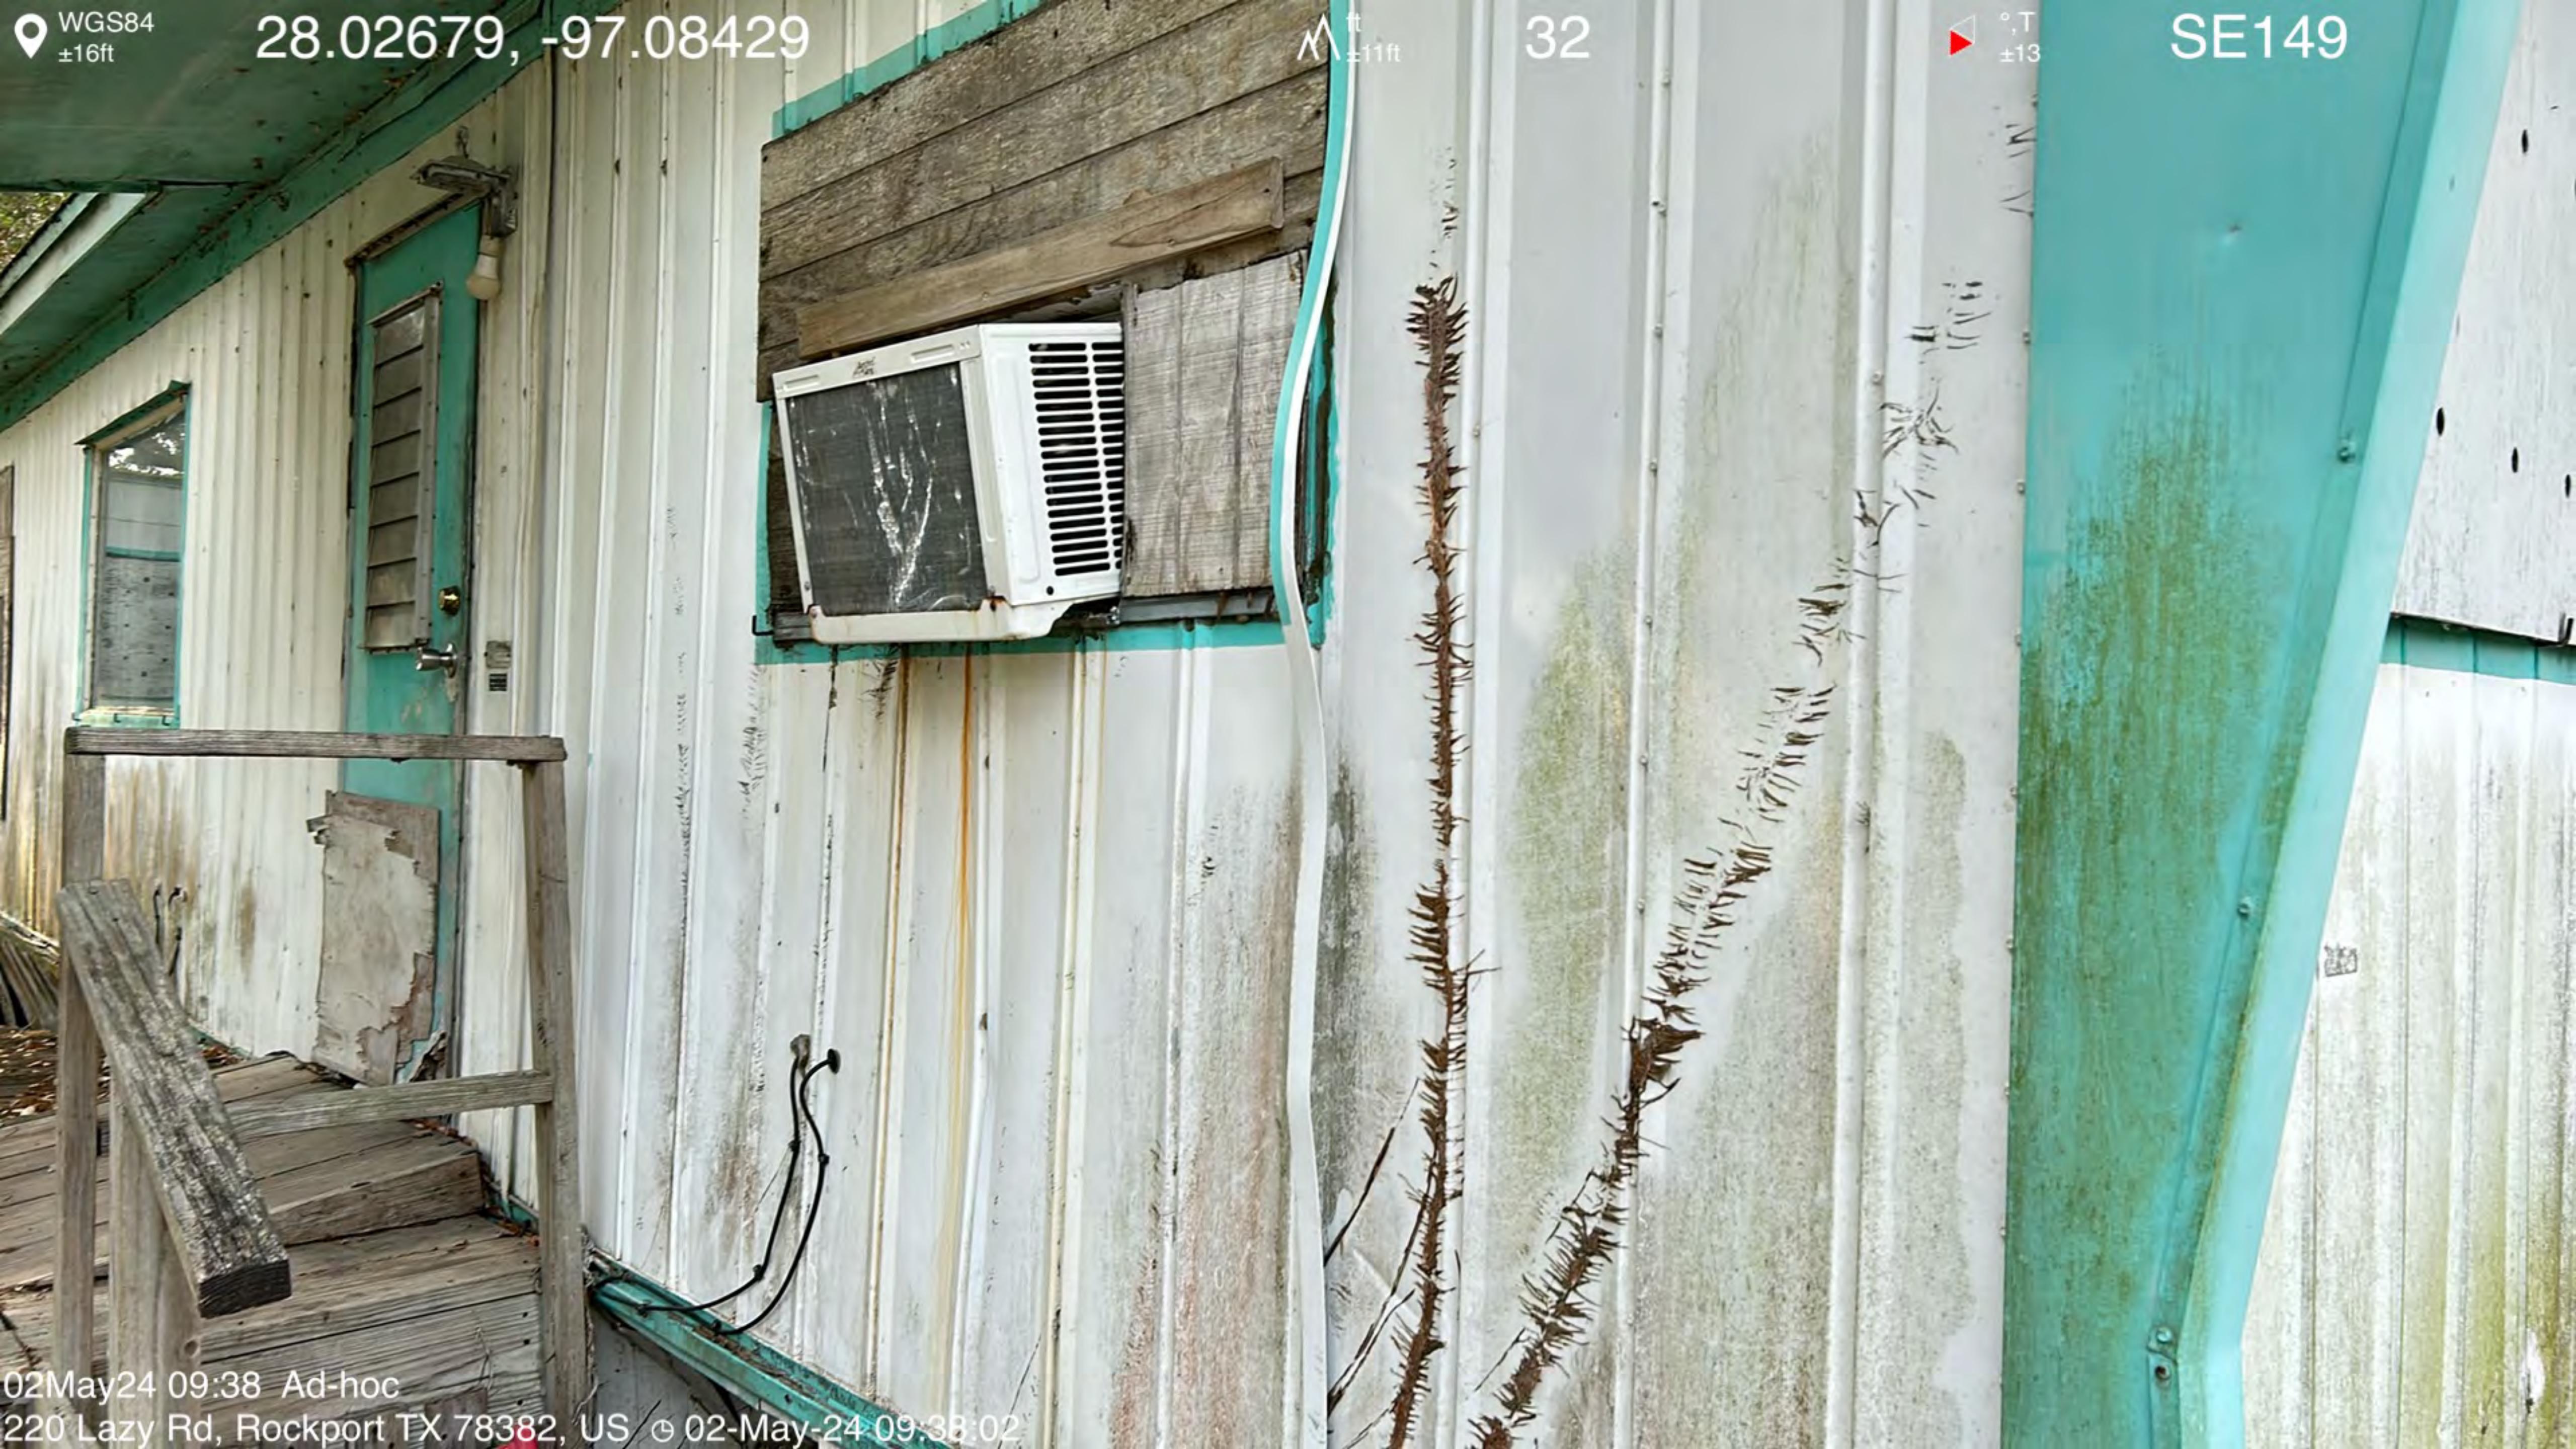
02May24 09:38 Ad-hoc  
220 Lazy Rd, Rockport TX 78382, US © 02-May-24 09:38:02

OIT Ramos is requesting that the structure be demolished, and the property cleaned, cleared and returned to its natural state. The request is due to the substantial deterioration of the framing of the mobile home along with wood rot of the flooring as well as the roof of the structure need complete replacement.
