BUILDING & STANDARDS  
COMMISSION  
PACKET

**July 18, 2024**

## BUILDING & STANDARDS COMMISSION AGENDA

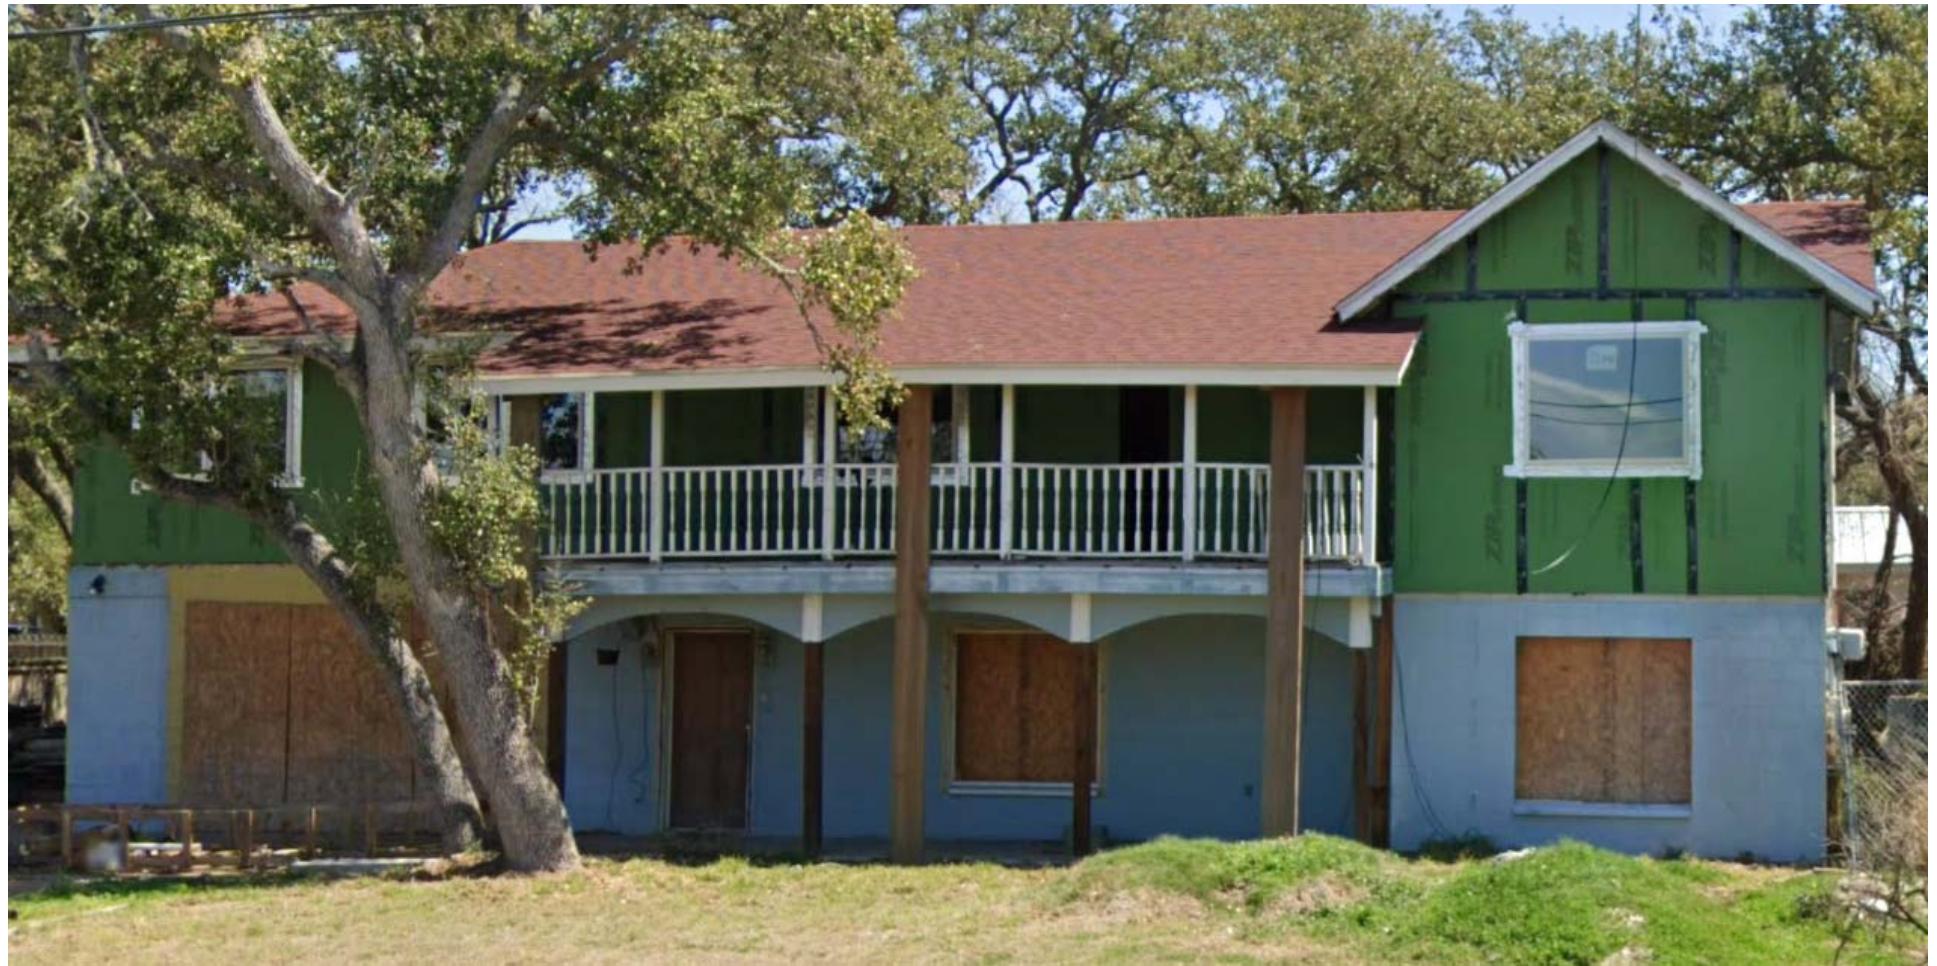
**UPPER DECK (BALCONY) REPAIR RECOMMENDATIONS  
(ENGINEER'S OPINION)**  
**Wednesday, September 20, 2023**

*Location:*  
**1122 N Ann St, Rockport, TX 78382**

**FRONT UPPER DECK (BALCONY) REPAIR RECOMMENDATIONS**

- ✓ CONNECT EXISTING 4X4 WOOD COLUMNS AT THE TOP TO THE HEADER BEAM AND ON THE BOTTOM TO THE CONCRETE FLOOR. SEE TENSION TIES, STRAP TIE, DETAIL PAGES LATER IN THIS REPORT.
- ✓ UTILIZE WIND-RATED CONSTRUCTION METHODS AS PER THE TDI WINDSTORM REQUIREMENTS.
- ✓ ADDING DIAGONAL KNEE-BRACING FROM THE EDGE OF THE BALCONY FLOOR TO THE 4X4 COLUMNS IS RECOMMENDED.
- ✓ HURRICANE TIES ARE RECOMMENDED AT BEAM-TO-COLUMN CONNECTIONS.
- ✓ ATTACH ROOF RAFTERS TO HEADER BEAM AND COLUMNS WITH RAFTER HANGERS – DETAILS ON PAGES LATER IN THIS REPORT.
- ✓ THE FLOOR OF THE BALCONY DECK SHALL BE REINFORCED WITH SOLID BOARD WHEREVER DETERIORATION IS SEEN.
- ✓ GUARDRAIL POST CONNECTIONS TO THE FLOOR SHALL BE REINFORCED WITH APPROPRIATE CONNECTORS.
